Drive Chain / Drive Train / Drive Shaft

Diagnostic Information and Procedures

Drive Chain Related Components

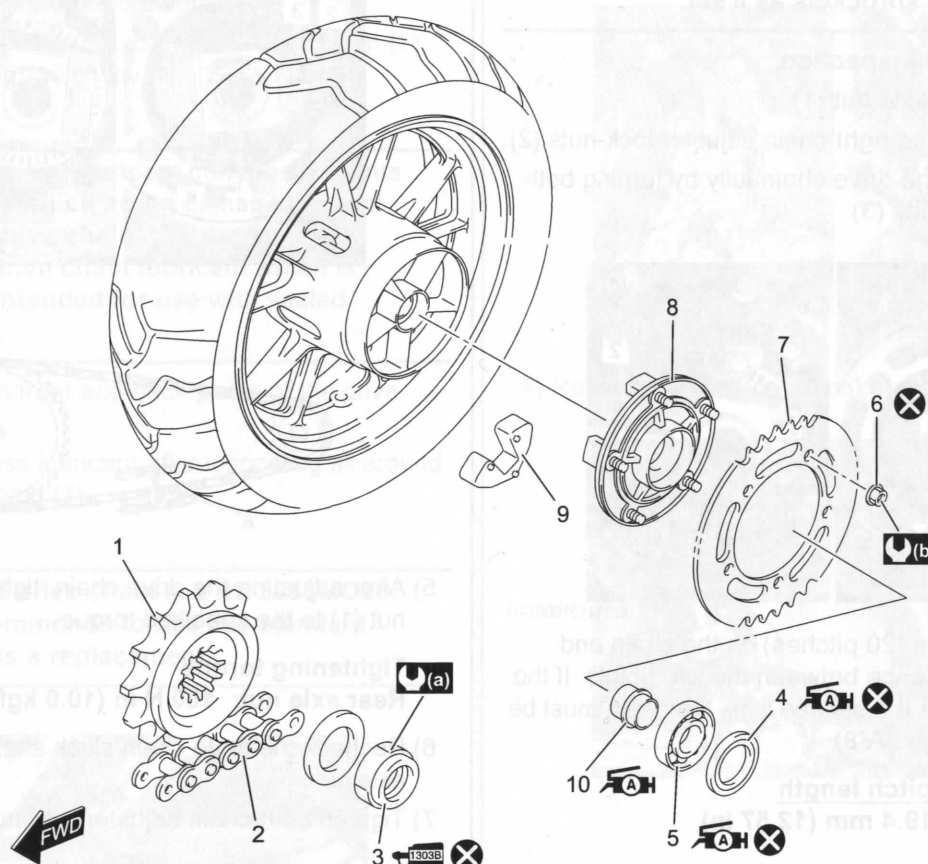
IE31J1310039-04

1. Engine sprocket	6. Rear sprocket nut	(a) : 115 N-m (11.5 kgf-m, 83.5 lbf-ft)
2. Drive chain	7. Rear sprocket	(b) : 60 N-m (6.0 kgf-m, 43.5 lbf-ft)
3. Engine sprocket nut	8. Rear sprocket mounting drum	AH : Apply grease.
4. Dust seal	9. Wheel damper	1303B : Apply thread lock to thread part.
5. Bearing	10. Retainer	X : Do not reuse.
