Rear Suspension On-vehicle Inspection

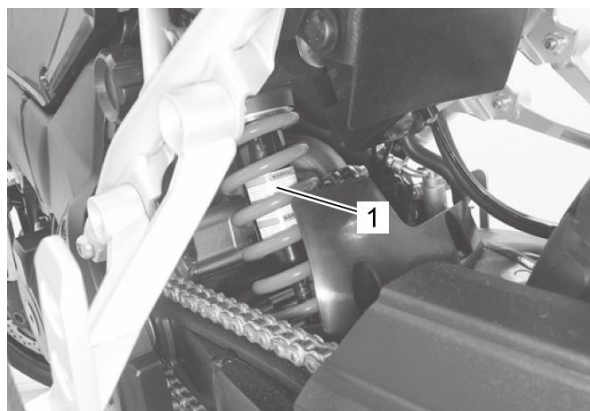
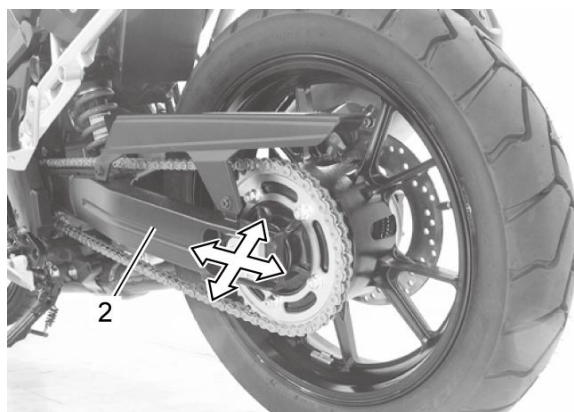
Inspect the rear shock absorber (1) for oil leakage and check that there is no play in the swingarm (2).

Replace any defective parts, if necessary.
